1. Report No. NTSB-HAR-76-4	2. Government Accession No.	3. Recipient's Catalog No.	
4. Title and Subtitle Highway Accident Report - Surtigas, S.A., Tank-semitrailer Overturn, Explosion, and Fire, Near Eagle Pass, Texas, April 29, 1975		5. Report Date May 5, 1976	6. Performing Organization Code

HIGHWAY ACCIDENT REPORT

SURTIGAS, S.A., TANK-SEMITRAILER OVERTURN,  
EXPLOSION, AND FIRE, NEAR EAGLE PASS, TEXAS  
APRIL 29, 1975

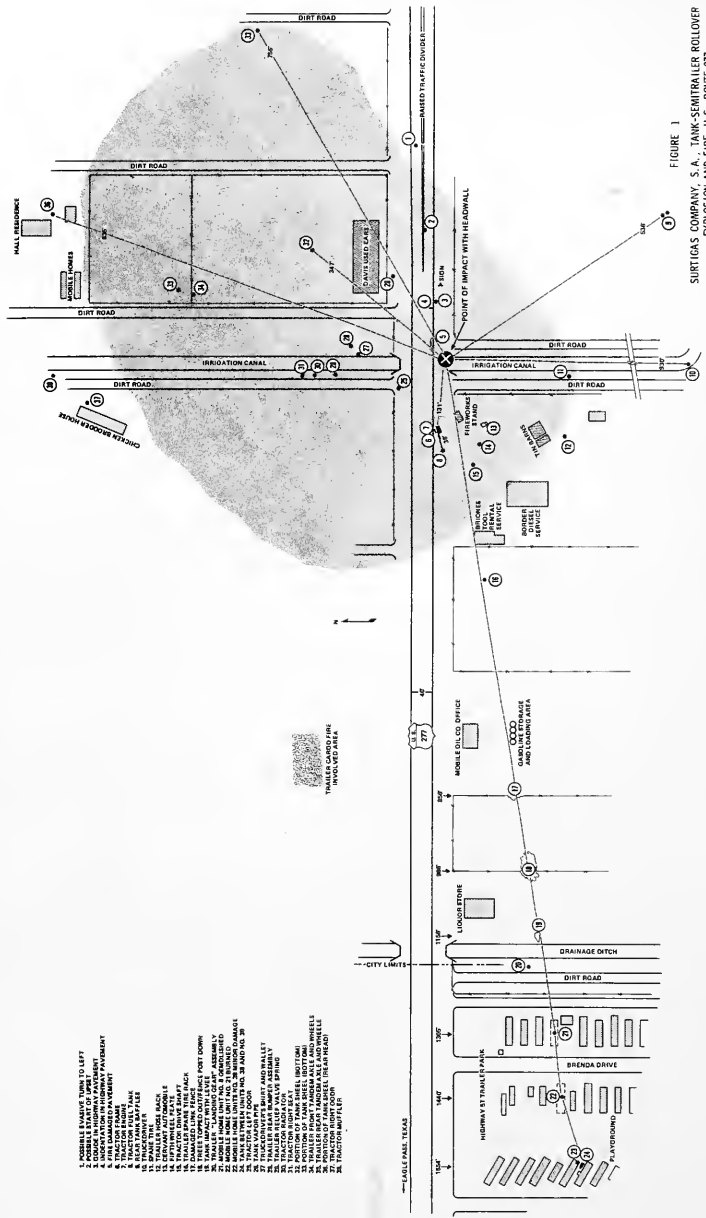
Figure 1. Accident site.

U.S. Route 277 was a two-lane, 40-foot-wide concrete roadway with a well-worn asphalt surface. (See Figure 1.) The eastbound and westbound lanes were divided by a double yellow centerline, which was also worn. The road crossed an irrigation canal at the accident site. Four hundred and thirty-one feet east of the irrigation canal, the roadway was intersected by U.S. Route 57. Near its intersection with Route 57, Route 277 widened and its lanes were separated by a raised concrete divider. There were 30-foot gravel and clay shoulders on each side of the roadway. The posted speed limit was 50 mph. The westbound truck approached the site on an average 1.70-percent downgrade. On the day of the accident, the visibility was 5 miles and the temperature was 80 degrees. Witnesses described traffic as light but steady.

A used-car facility was located 200 feet east of the intersection with Route 57, north of the roadway and east of the irrigation canal. North of this facility was a large fenced lot which contained wrecked and disassembled vehicles. South of the roadway and west of the canal to the Eagle Pass city limits were four businesses widely separated by open fields. Inside the city limits, south of the roadway, was a trailer park. The 50 vehicles parked on the shoulder of the westbound traffic lane denied a clear escape area for westbound traffic. The evasive maneuvers of the truck took place in the vicinity of this congestion.

The irrigation canal which ran north and south under the roadway had concrete headwalls 28 feet to the north and 29 feet to the south of the roadway's edge. The concrete headwalls were 17.5 feet long, 12 inches thick, and 23 inches high, and constructed of reinforced concrete. They were not protected by a barrier.

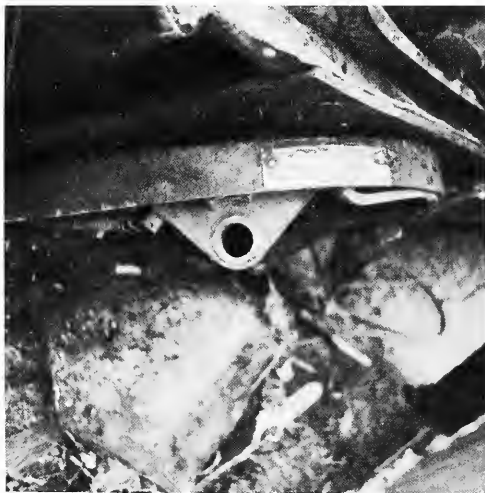
The fifth wheel was found attached to the trailer king pin. The vertical flange of the fifth-wheel plate, adjacent to the fifth-wheel cross-shaft, was bent outward. (See Figure 2.) The slide plate was found 50 feet south of the tractor. The transverse tube through which the fifth-wheel cross-shaft normally is positioned was bent upward and was disconnected from its right-side attachment. The metal failed in the weld. The fore-and-aft positioning plunger was flush with the bottom of the slide plate. (See Figure 3.)

Figure 2. Fountaine fifth wheel still attached to front section of tank after the accident.

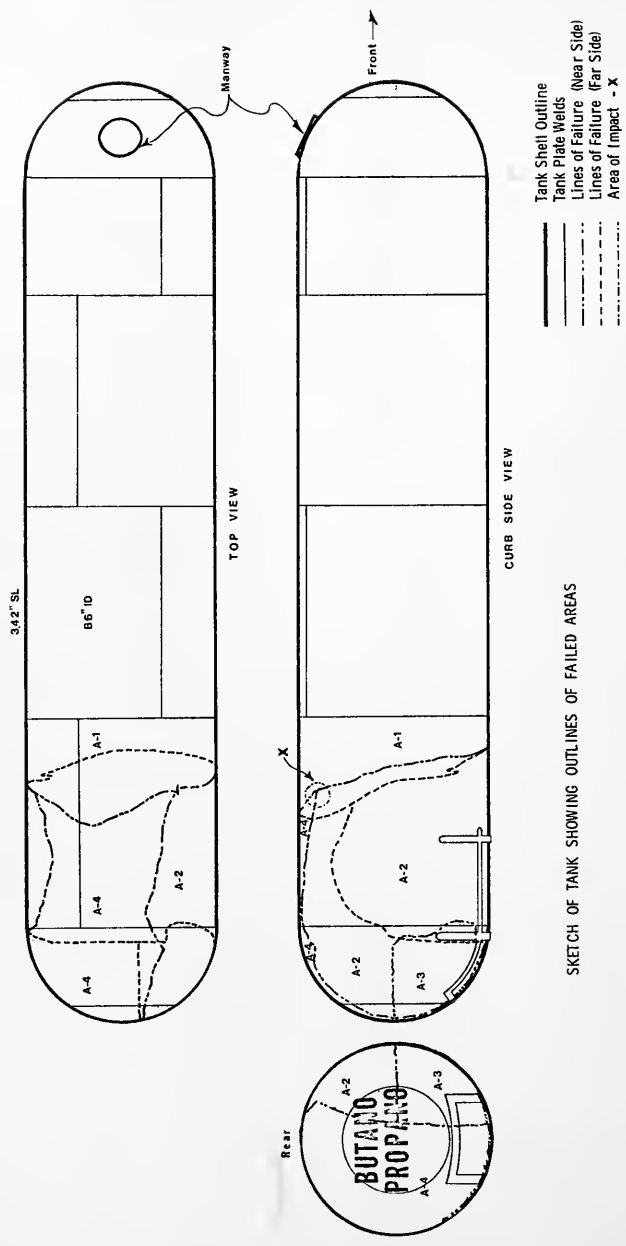
Figure 4.

The open end of the forward section of the tank was deformed into an ellipse. (See Figure 4.) The edges of the failure area had a mechanically deformed, gouged, and stretched dent. The dent was located on the right side of the tank, 26 inches from the top longitudinal centerline and 22 feet 9 inches rearward of the front head-to-shell weld. At the point of impact, the shell material was gouged from an original thickness of 0.387 inches to 0.279 inches. The internal tank pressure of 87 psig combined with the impact load to cause a shear-type failure around the tank circumference. The pressure, acting upon the tank material at the point of initiation of the crack, produced the extensive spread of the initial crack and permitted the violent rupture and separation of major parts of the tank.

The Safety Board analyzed a sample of the metal from the suspected impact area, and found no evidence of a preexisting crack. The analysis showed that the fracture appeared to be caused by an overload separation.

SKETCH OF TANK SHOWING OUTLINES OF FAILED AREAS

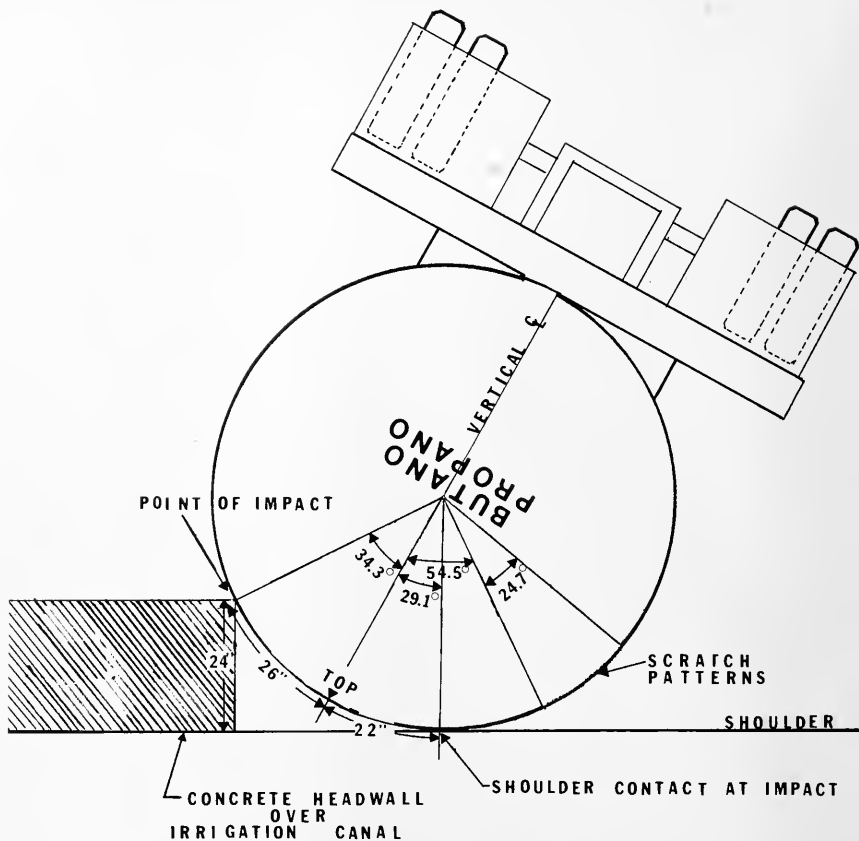
When the trailer separated from the tractor, the upsetting forces on the tractor were removed. The tractor dropped onto its right wheels, continued westward, and stopped opposite the headwall of the irrigation canal. The trailer rolled onto its left side and slid toward the concrete headwall and struck it. (See Figure 5.)

At impact, the tank shell was gouged severely and was forced into an elliptical shape. Impact forces also caused the tank to rotate counterclockwise about 40 to 50 degrees and to rebound to the south edge of the eastbound lane. The tank shell began to crack where it struck the headwall. The internal tank pressure of 87 psig combined with the impact load to cause a shear-type failure around the circumference of the tank.

If highway design and construction standards and AASHTO recommended practices had been followed in the construction or remodeling of the concrete headwall, it would have been flush with the ground and the tank would not have ruptured. If remodeling of the headwall was not possible, it should have been protected by a barrier. Even though the truck might have penetrated the barrier, the barrier might have at least absorbed

FIGURE 5. CALCULATED ATTITUDE OF TANK-SEMITRAILER AT IMPACT WITH CONCRETE HEADWALL

enough energy or redirected the tank to prevent the rupture of the tank shell. The FHWA and AASHTO should encourage the States to consider such hazards in the development of their spot improvement programs.
